Defective Swivel Snaphook Prompts WSBC Warning

SWIVEL SNAPHOOK INSPECTION NOTIFICATION

Inspection notice for GFP products featuring a possible unsafe condition due to a supplier defect in a specific style of swivel snaphook supplied to Guardian between 8/26/2011 and 6/25/2012

Date: 6/26/2012

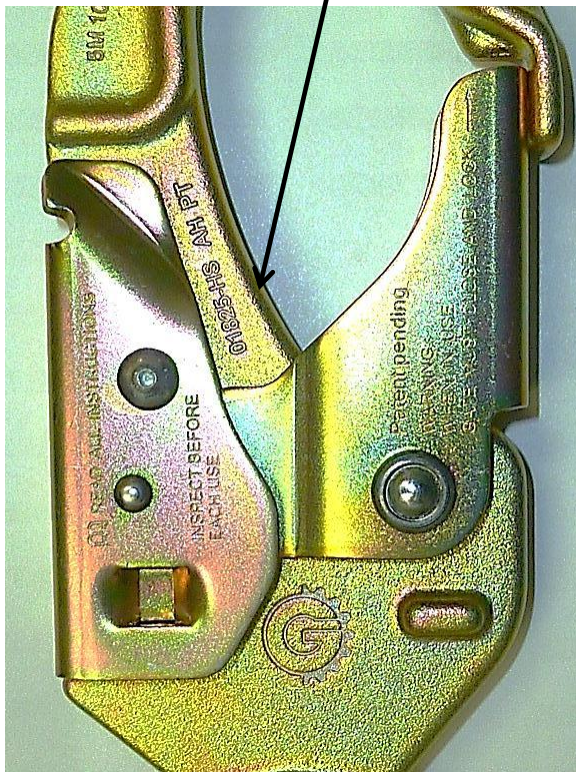
Marked with part # 01825-HS or 01826-HS on the hook body

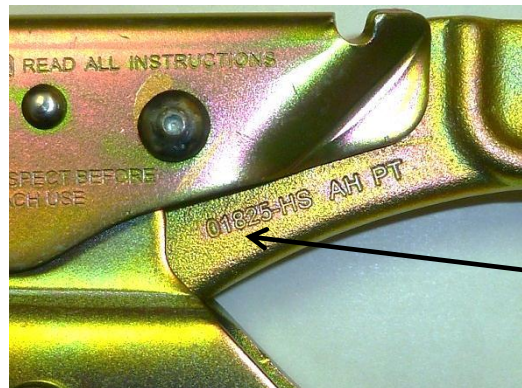
Marked with Guardian logo at hook base

Marked with part # 01825-HS or 01826-HS on the hook body

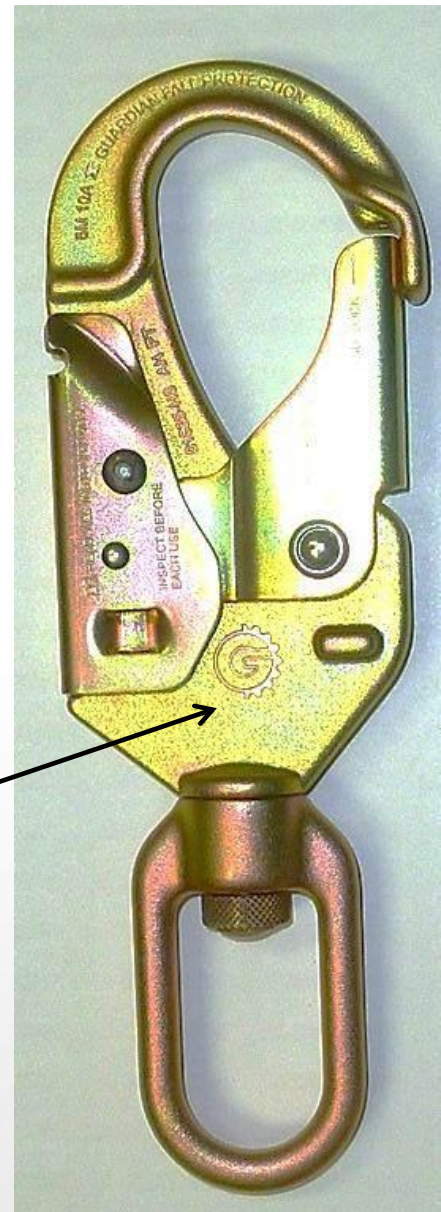
Full photo of the potentially defective swivel snaphook.

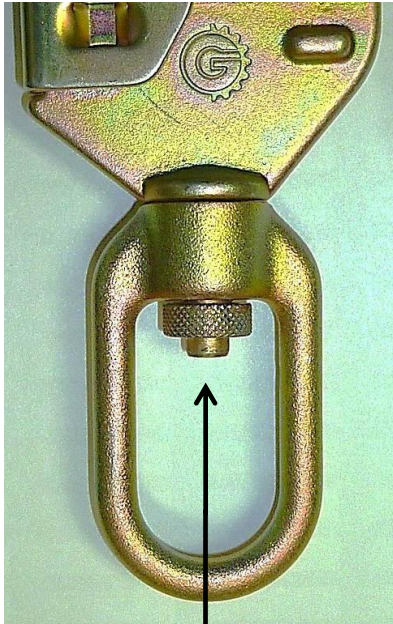
DEFECTIVE CONDITION

The potentially dangerous and faulty condition was caused when GFP's supplier of a particular swivel snaphook missed a swaging operation that encapsulates the swivel eye and prevents the threaded nut from backing off of the hook stem. This situation is restricted to a certain type of swivel snaphook supplied to GFP and is identified in this notice. Upon discovery, both GFP and the supplier have increased inspection processes to ensure this cannot occur in the future. Supplier and GFP inventories have been inspected for this condition upon discovery. **No defective units were found in inventory.** Any products you receive after June 26th have been 100% inspected specifically for this condition and any other defect.

BAD HOOK. STEM PROTRUDES STRAIGHT THROUGH THE NUT. STEM HAS NO MUSHROOM SHAPE FLARED OVER THE NUT. NUT CAN BACK OFF THREADED STEM.

Remove the product from service immediately.

Contact Customer Service at GFP (800-466-6385) to be assigned a unique RQC- return number. Guardian will provide shipping instructions for returning products and coordinating replacements for units that have the defective swivel snaphooks. Guardian will replace the product and cover the freight costs.

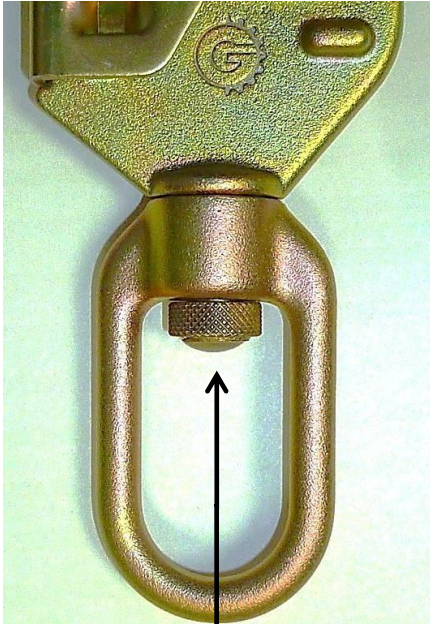
NORMAL CONDITION

NORMAL SWAGED HOOK. GOOD HOOK. STEM FLATTENED IN A MUSHROOM SHAPE. ANY SORT OF SWAGE MEANS HOOK IS GOOD. NUT CANNOT BACK OFF STEM.

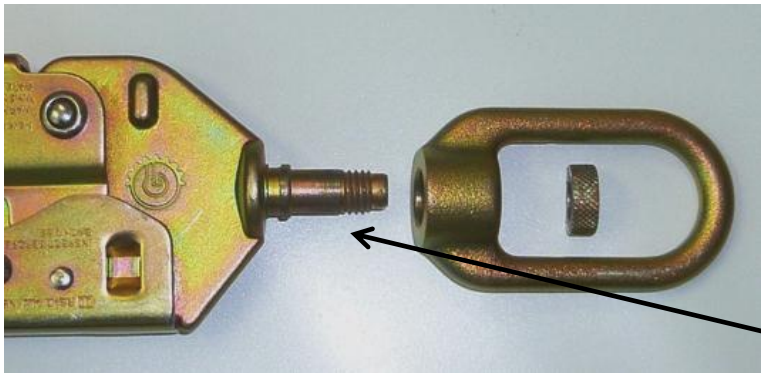
BAD HOOK. STEM OF HOOK BODY WAS NOT SWAGED OVER NUT. THREADED NUT IS CAPABLE OF SPINNING OFF THE STEM.
